RESIDENTIAL SPLITS

Mingledorff's Technical Services / SE

03/19/2025

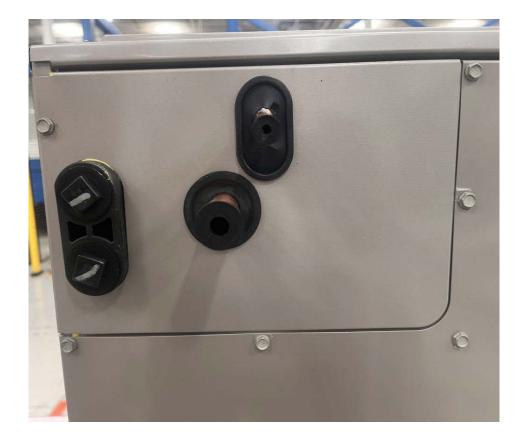
Reported Situation	Status	Implementation Date (Week/Year)
Liquid/Suction tube door grommets - loose	Complete	0224J

Liquid and suction stub grommets were not staying in panel opening around tube. Created air leaks and a poor-quality perception. **Solution:**

Grommets were resized to fit into panel opening while creating a tight seal on copper stubs.

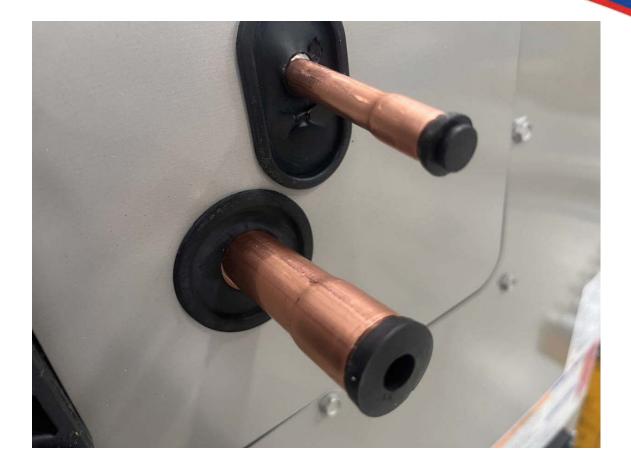
Reported Situation	Status	Implementation Date (Week/Year)
Liquid/Suction tube plugs - leak	Complete	0624J

Nitrogen is leaking out of coils around rubber plugs. Customer perspective –if they don't hear gas escaping from coil when removing plugs, the coil has a leak.

Nitrogen pressure was adjusted, and rubber plug material was changed to maintain a higher pressure in coils, so customers could hear gas escape during plug removal.

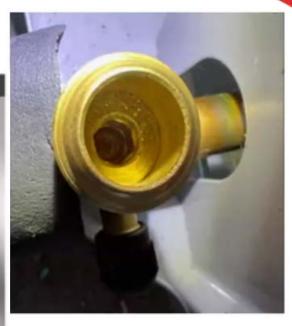
Situation: We continue to receive reports that the service tech are unable to open the service valves. The hex socket inside of the valve has become "stripped" and can't be opened.

Findings: Upon investigation of the reports, we are finding the hex socket isn't completely "stripped" the entire length of the socket. When a valve is tight the multi-step tool being used by the service tech isn't engaging enough of the socket & stripping the valve.

- Liquid Service Valve Full Insertion Depth is 1-3/8"
- Suction Service Valve Full Insertion Depth is 1"

Recommendation: Don't use the hex multi-size tool because is doesn't all full engagement to the bottom of the valve socket. Especially when breaking the valve free for the first time. Use the standard hex "Allen" wrenches that fit the entire socket depth or purchase the correct depth hex multi-size tool.

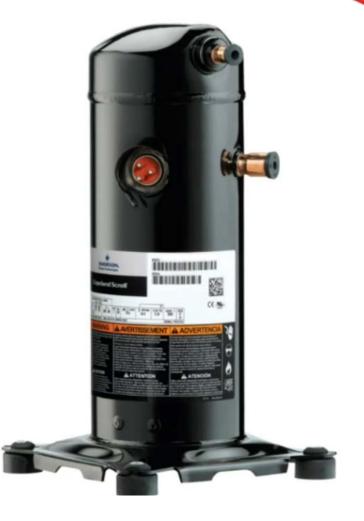
COPELAND K7 COMPRESSOR INVESTIGATION

- Reverse rotation may produce a short duration sound at shutdown; lasting until discharge and suction gas pressure equalizes.
- While reverse rotation noise does not damage the compressor and has no impact on compressor reliability, the noise may be objectionable to some customers.
- A design change internal to the compressor has been implemented on Copeland 3.5, 4, and 5ton K7 compressors manufactured after December 1, 2024, that eliminates most reverse rotation noise at shutdown.

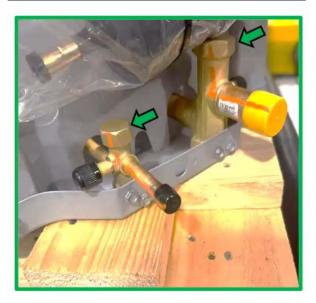
Multiple reports about missing service valve caps both liquid line and suction line of condenser units, most of the units were built at CMX-C during 2024.

What? Missing caps on service values.
Why? Values have no protection.
Who? Field Reports
When? June 17, 2024.
Where? Northeast / Midwest
How much? multiple serial number reports

Added witness marks on each service valve. Placed more service valve caps at end of run test. Issued a Factory Quality Alert to all lines. Reports

Witness mark applicable since Wk 26, 2024
