TOSHIBA CARRIER CLEAR ERROR CODES AT ODU

MINGLEDORFF'S TECHNICAL SERVICES

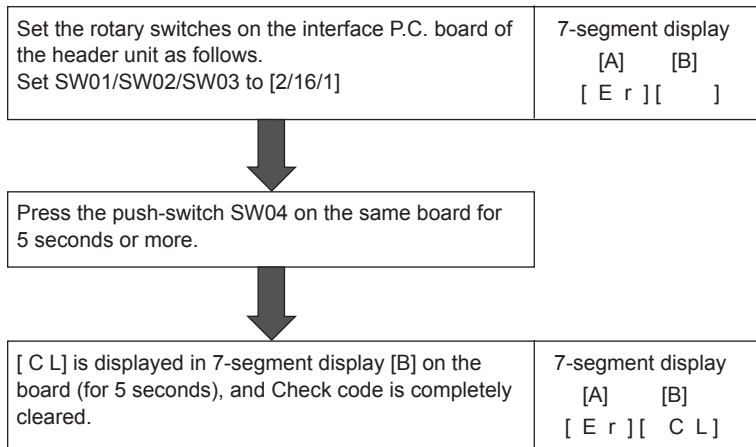
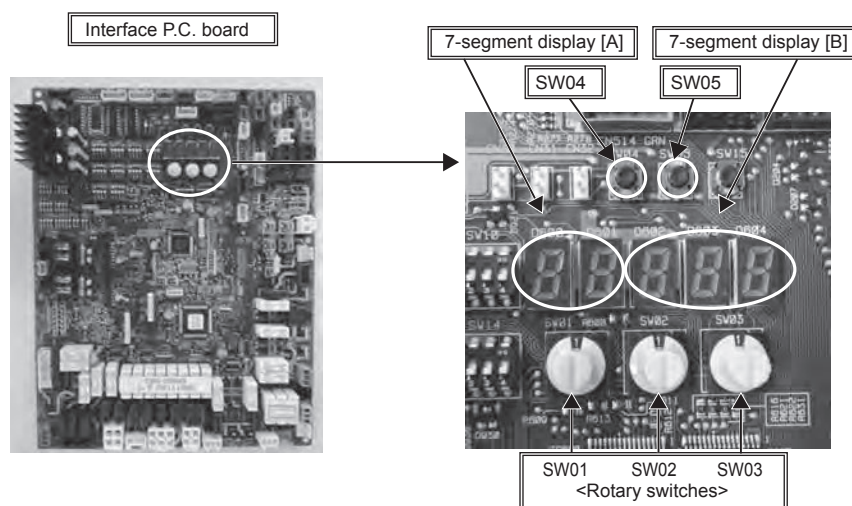
(2) Clearing check code by using switches on the interface board of the header unit

Using the switches on the interface P.C. board of the header unit, this function is to clear the currently detected check code for each refrigerant circuit system without resetting the power supply.

Check codes in both outdoor and indoor units are once cleared, and check code detection is performed again.
